SICK COLLEGE POOL GETS RX WITH SWIM COACH'S IAQ CONCEPTS AND DESIGN.

Carlisle, PA—Dickinson College Aquatics.

case study

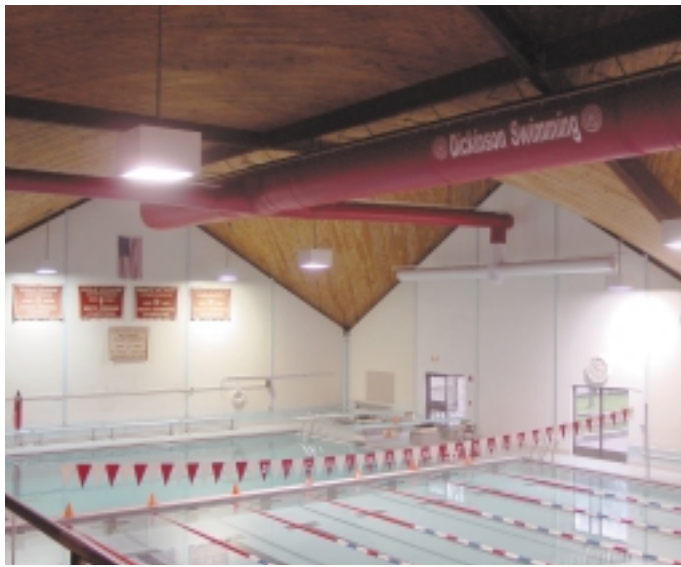
percent through the natural porosity of the fabric. The remaining air is delivered through a linear mesh diffuser in each of the four 20-inch diameter perpendicular branches that spray the windows and the spectator section with 82°F air.

The trunk line and branches were ordered in red and white, respectively, to match Dickinson school colors. The trunk also sports the school logo that DuctSox custom silk-screened onto the fabric.

For best air distribution and aesthetics, Richards wanted the trunk line at the center of the roof's peak, however existing lighting fixtures would have been blocked by the duct. Ellerman conceived of a fixture retrofit that would allow both the trunk and the lighting to hang at the center. He lowered the lighting below the trunk line by extending the ceiling mounted conduit pendants into an "O" shape that surrounds the duct and connects to the fixture below the duct.
